CONCEPTUAL DESIGN

landscape architectural design services

FOR: HIGHLANDS BOROUGH DATE: 4/26/23

INVENTORY & ANALYSIS - EXISTING CONDITIONS MAP

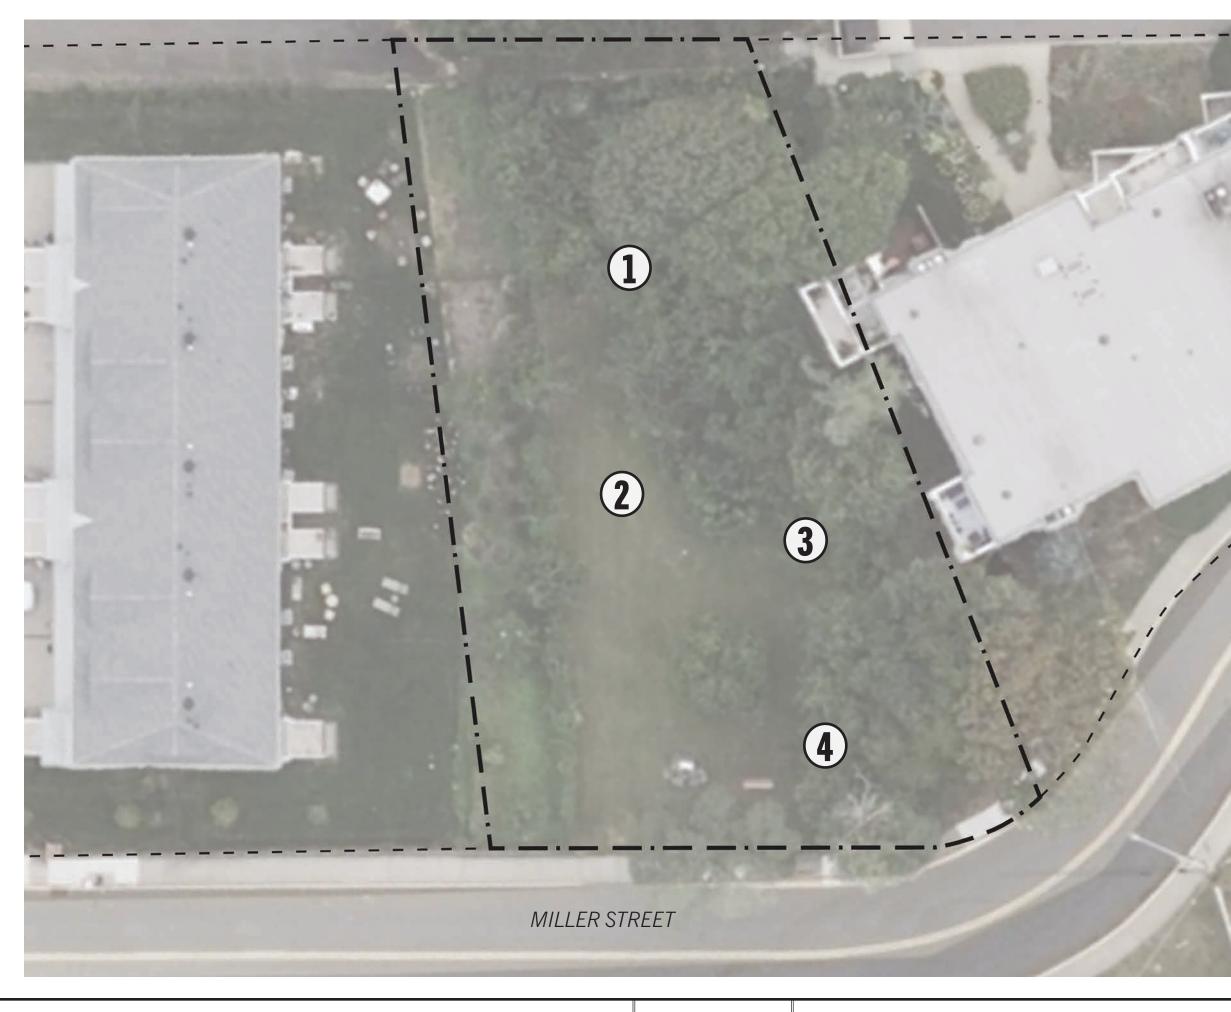
1. dense vegetation on slope 2.flat linear area *3. existing peanut stone wall* 4. wooded slope and existing memorial

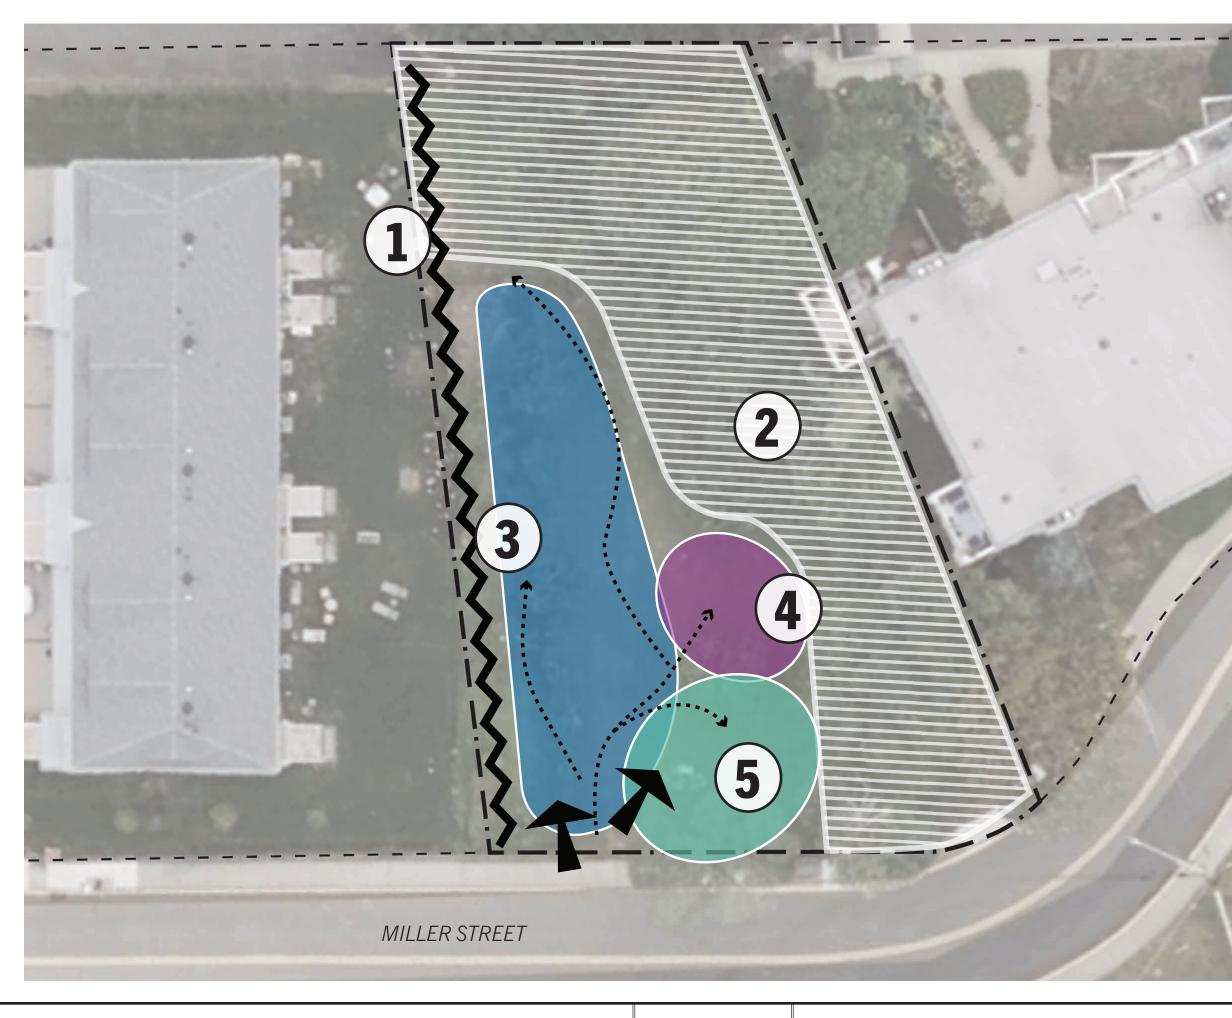
INVENTORY & ANALYSIS - OPPORTUNITIES AND CONSTRAINTS DIAGRAM

1. visual screen

screen views to park from adjacent property-replace existing chain link fence with a board on board wood fence

2. wooded slope

the existing wooded slope, very steep in some parts, creates an opportunity for a naturalized and peaceful backdrop to the park.

3. flat area

the existing grade in this area is relatively flat

4. focal point

the slight increase of grade and off center location of this area create an excellent opportunity for a natural focal point. This would be a great area for the memorial's relocation.

5. activity

programming and activity would work well in this area. The existing walls and proximity to the park's entrance make it accessible and visible.
